Existing on-site wastewater treatment systems assessment in Darfield

Sanitary survey summary report

Canterbury
District Health Board
Te Poari Hauora o Waitaha

Prepared for the Protection Team
by the Information Team
Community & Public Health
April 2014
Author: Hannah Mulrine
Peer Reviewer: Dr Annabel Begg

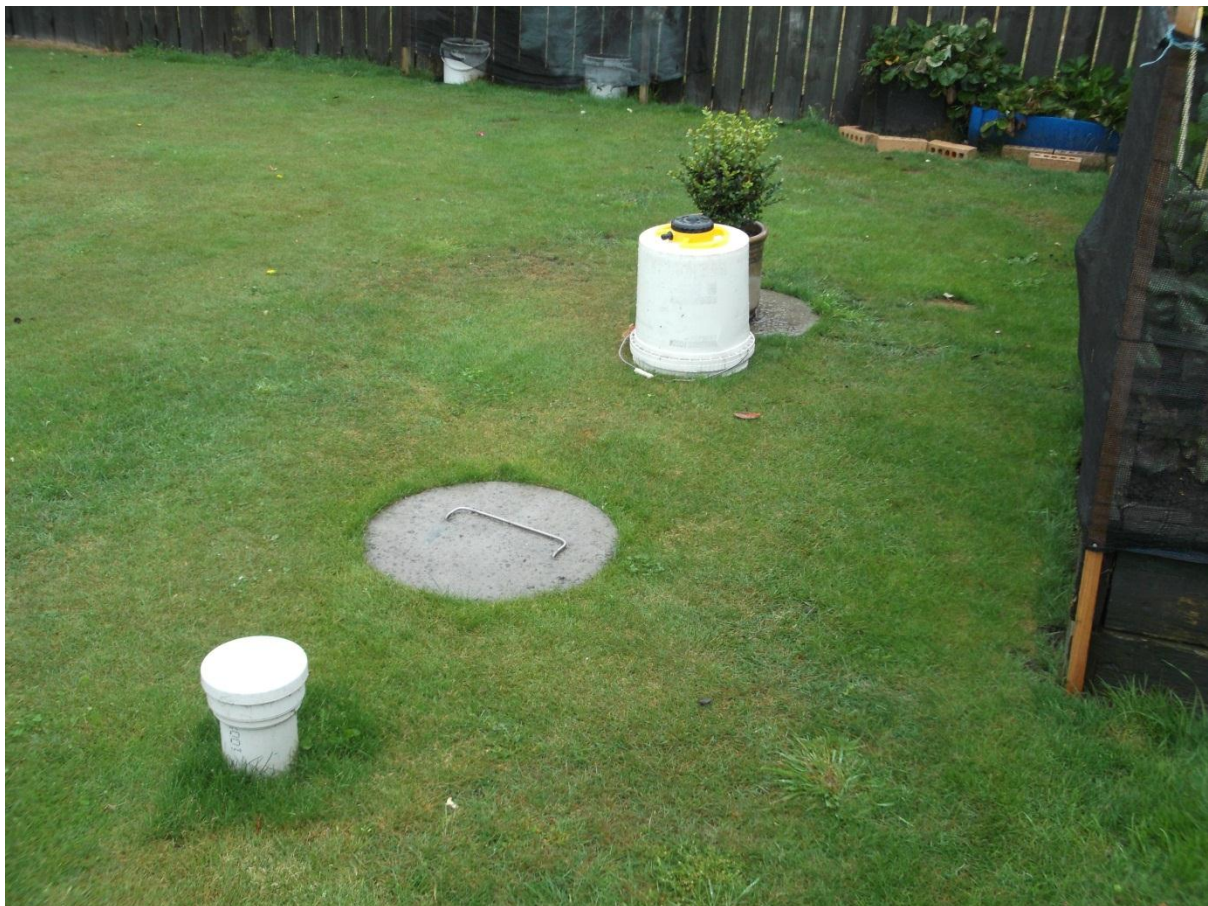
Figure 14. Septic tank vent and inspection hatch(es) visible in the lawn of a residential property

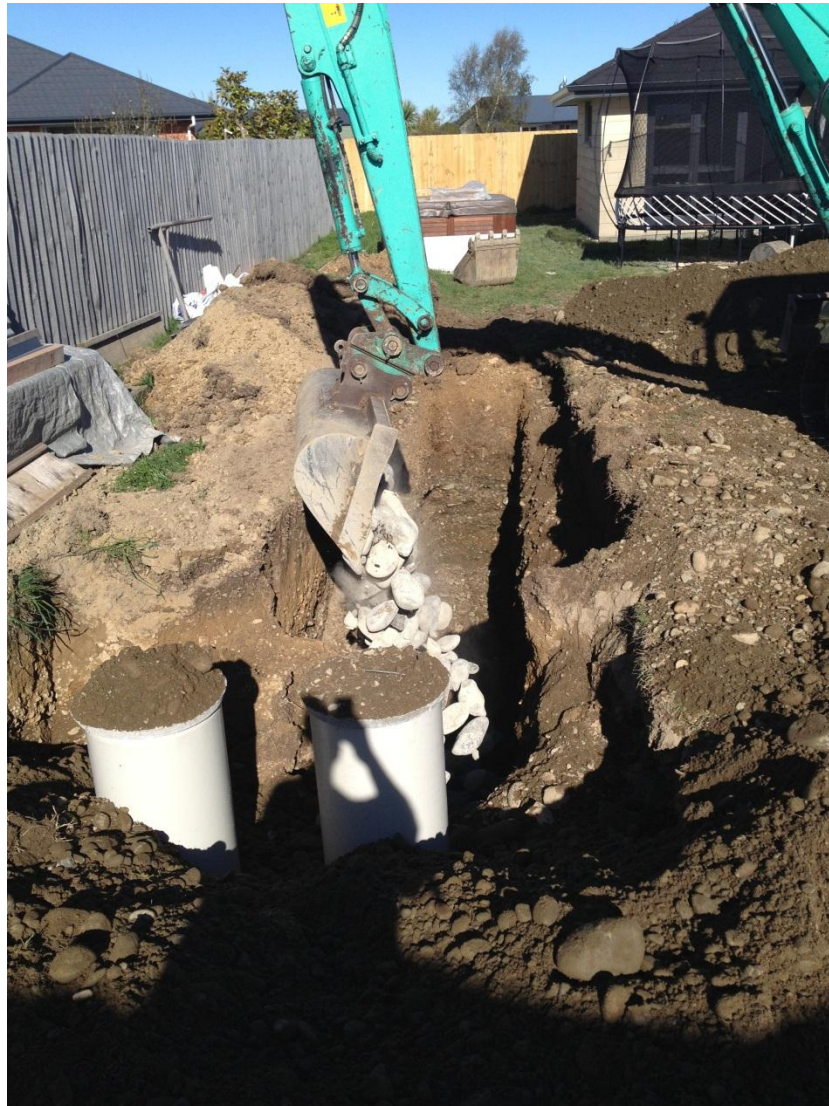
From a brief visual inspection, a small number of minor problems/system failures were observed. These included slightly sunk/uneven ground near the system (9 sites), odour (5 sites), slow plumbing drainage (2 sites), boggy ground (1 site), many trees growing over the septic system area (1 site), greener grass over the tank area (1 site), and a loosely-fitting hatch (1 site). No liquid/discharge on the ground surface or discharges to a ditch/creek or low point were observed on any of the sites. One septic system was currently being serviced due to collapse of the tank (Figure 15).

Figure 15: Repair of boulder pit in a residential property

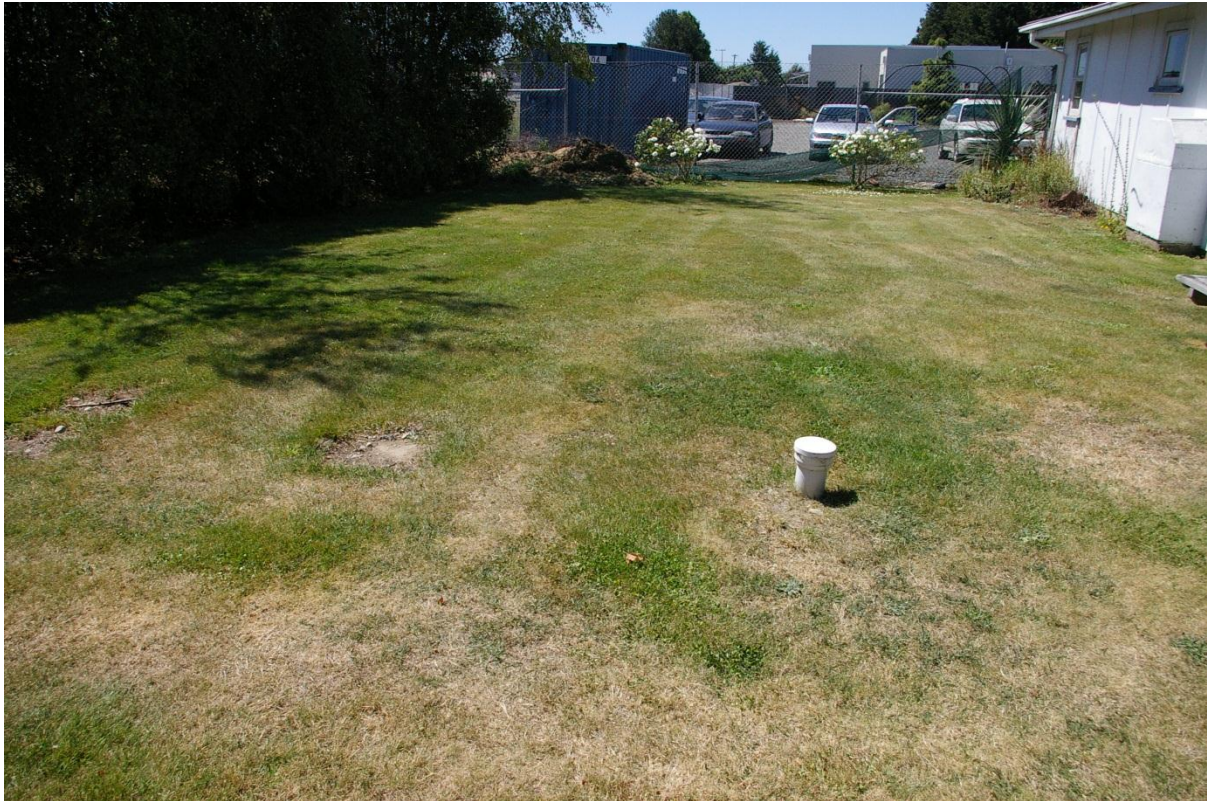
Figure 17. Septic tank vent and disposal field on a non-residential property

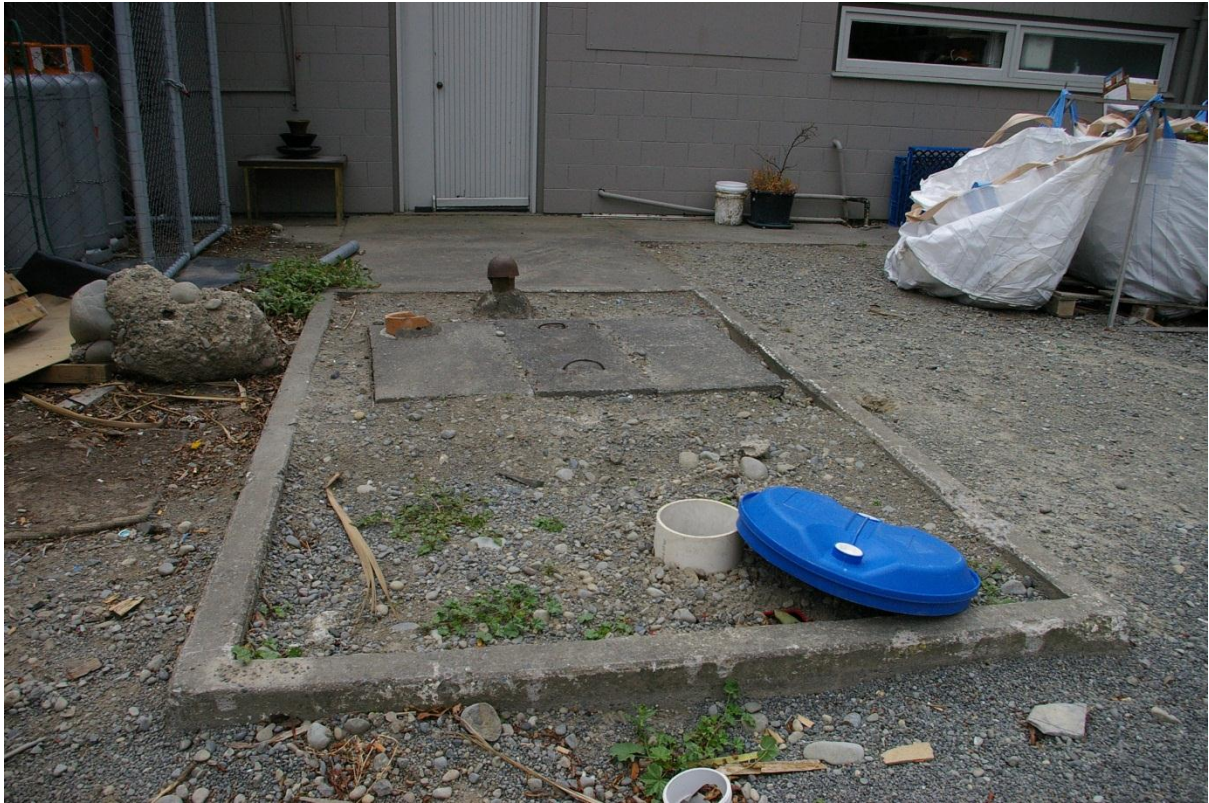
Figure 18. Septic tank vent, tank area, and tank access point on a non-residential property

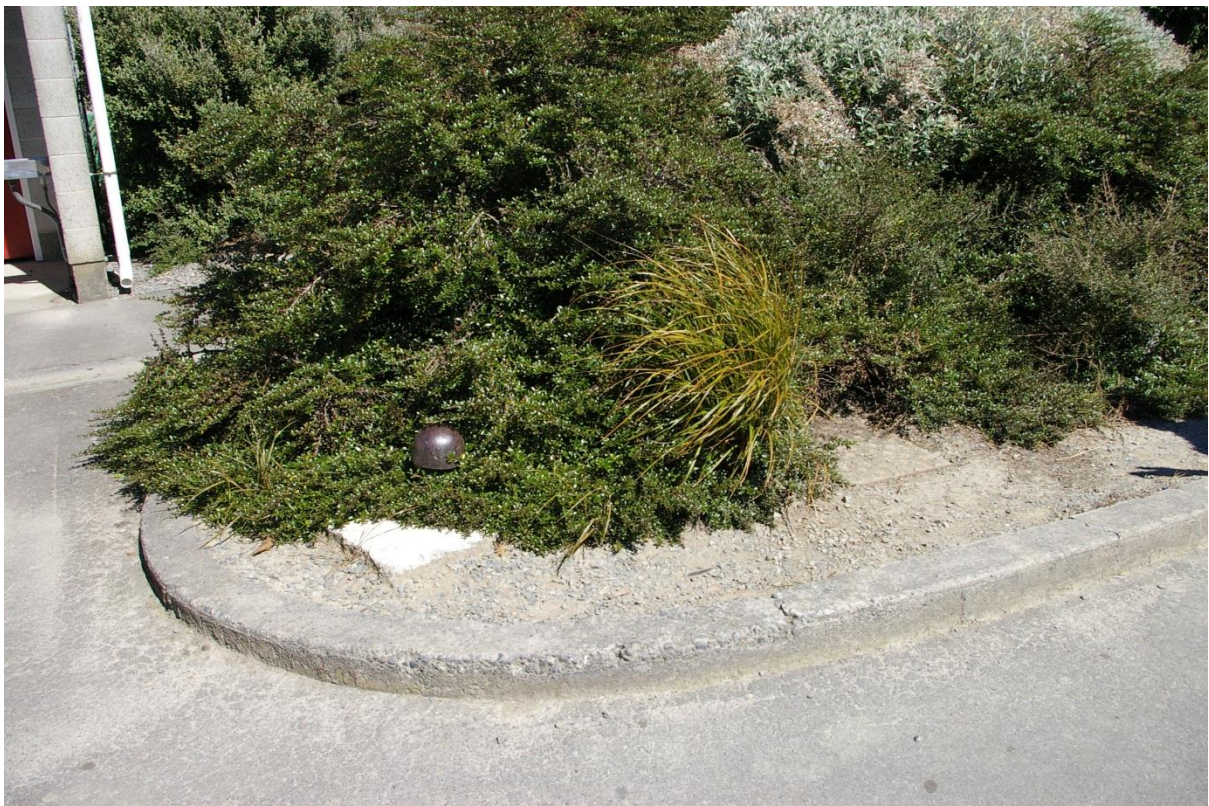
Figure 19. Septic tank vent and tank area on a non-residential property

On all sites, the septic tank area was protected from vehicle traffic/parking (Figure 19). The drainage/disposal area was protected from vehicle traffic/parking on five sites, but not on two sites.

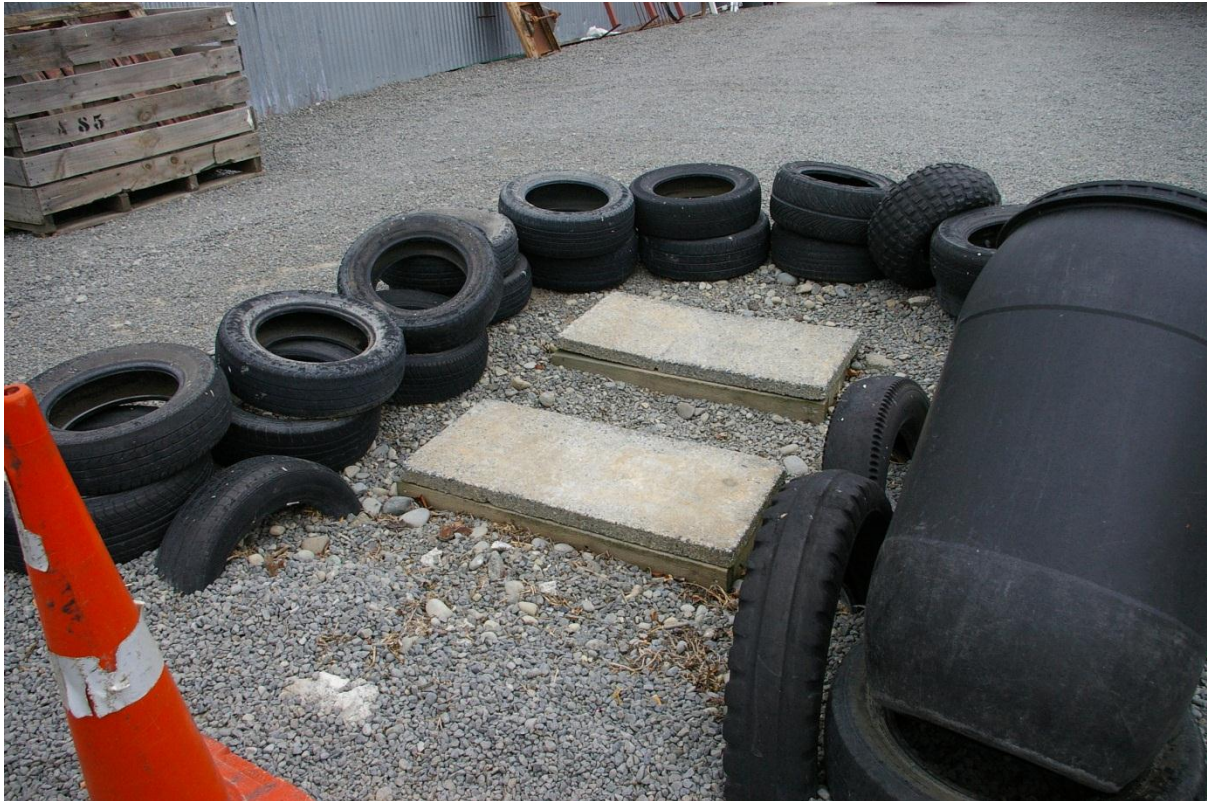
Figure 20. Septic tank area protected from vehicle traffic/parking on a non-residential property
